D'APPOLONIA CONSULTING ENGINEERS INC PITTSBURGH PA
NATIONAL DAM INSPECTION PROGRAM. CLOVER DAM (NDI ID NUMBER PA-4--ETC(U)
JUN 80

PHASE I REPORT
NATIONAL DAM INSPECTION PROGRAM

NAME OF DAM: Clover Dam
STATE LOCATED: Pennsylvania
COUNTY LOCATED: Jefferson
STREAM: Clover Run, a Tributary of the East Branch of Mahoning Creek
SIZE CLASSIFICATION: Small
HAZARD CLASSIFICATION: High
OWNER: Western Pennsylvania Water Company
DATE OF INSPECTION: April 22, 1980 and April 30, 1980

PHASE I REPORT
NATIONAL DAM INSPECTION PROGRAM
CLOVER DAM
(NDI LD PA-420)
(DER LD 33-4)

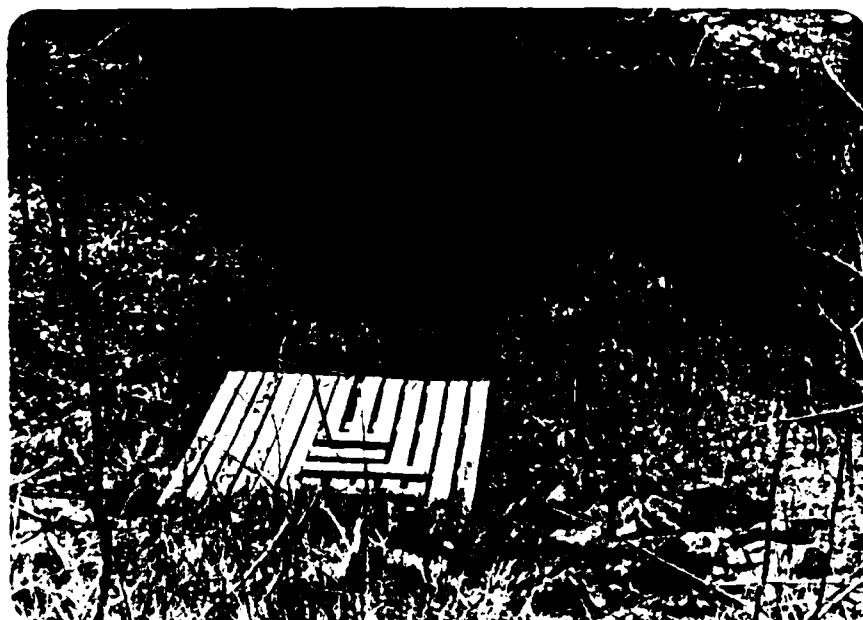
Photograph No. 5
Outlet pipe valve chamber.
